**Analysis of historic decorative schemes
“Thornbank”, Falcon Cliff Terrace, Douglas, Isle of Man
Designed by MacKay Hugh Baillie Scott (1897)**

Manx National Heritage

Author: Paul Croft (Conservator & Research Fellow)

February 2016

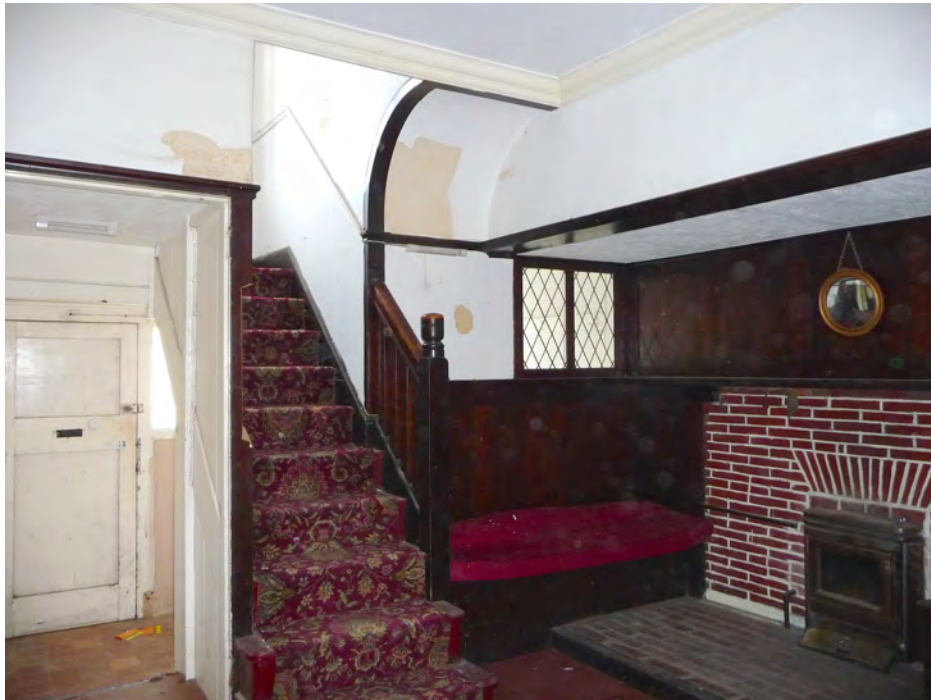
3.2: (Fig.5) The Entrance Hall

All the joinery in this area is currently varnished dark oak, which reflects its original appearance. The timber coving running around the perimeter of the ceiling is currently painted white, but this too was originally varnished dark oak (see fig.6).

The walls

The walls in the Entrance Hall are currently covered in lining paper and painted white. There is a frieze running around this area at high level between the picture rail and ceiling coving, clearly visible behind an area of paper that has been removed depicting a repeating pattern of a ship in sail.

This design was painted in soft, water-based distempers on a distemper background and is very fragile. This original decorative scheme was eventually papered over and painted white, obscuring the design and preserving it behind the paper. The application of a water based wall paper paste directly onto the surface reactivated the glue binder in the distemper resulting in the loss of some of the ochre pigments when the paper was removed, leaving behind faint traces of the outline of the original design.

The remaining wall faces in the Entrance hall were originally ochre distempered in the same background colour as the upper wall face frieze (see fig.8), with this colour extending into the upper wall face of the stair well (above dado level only).

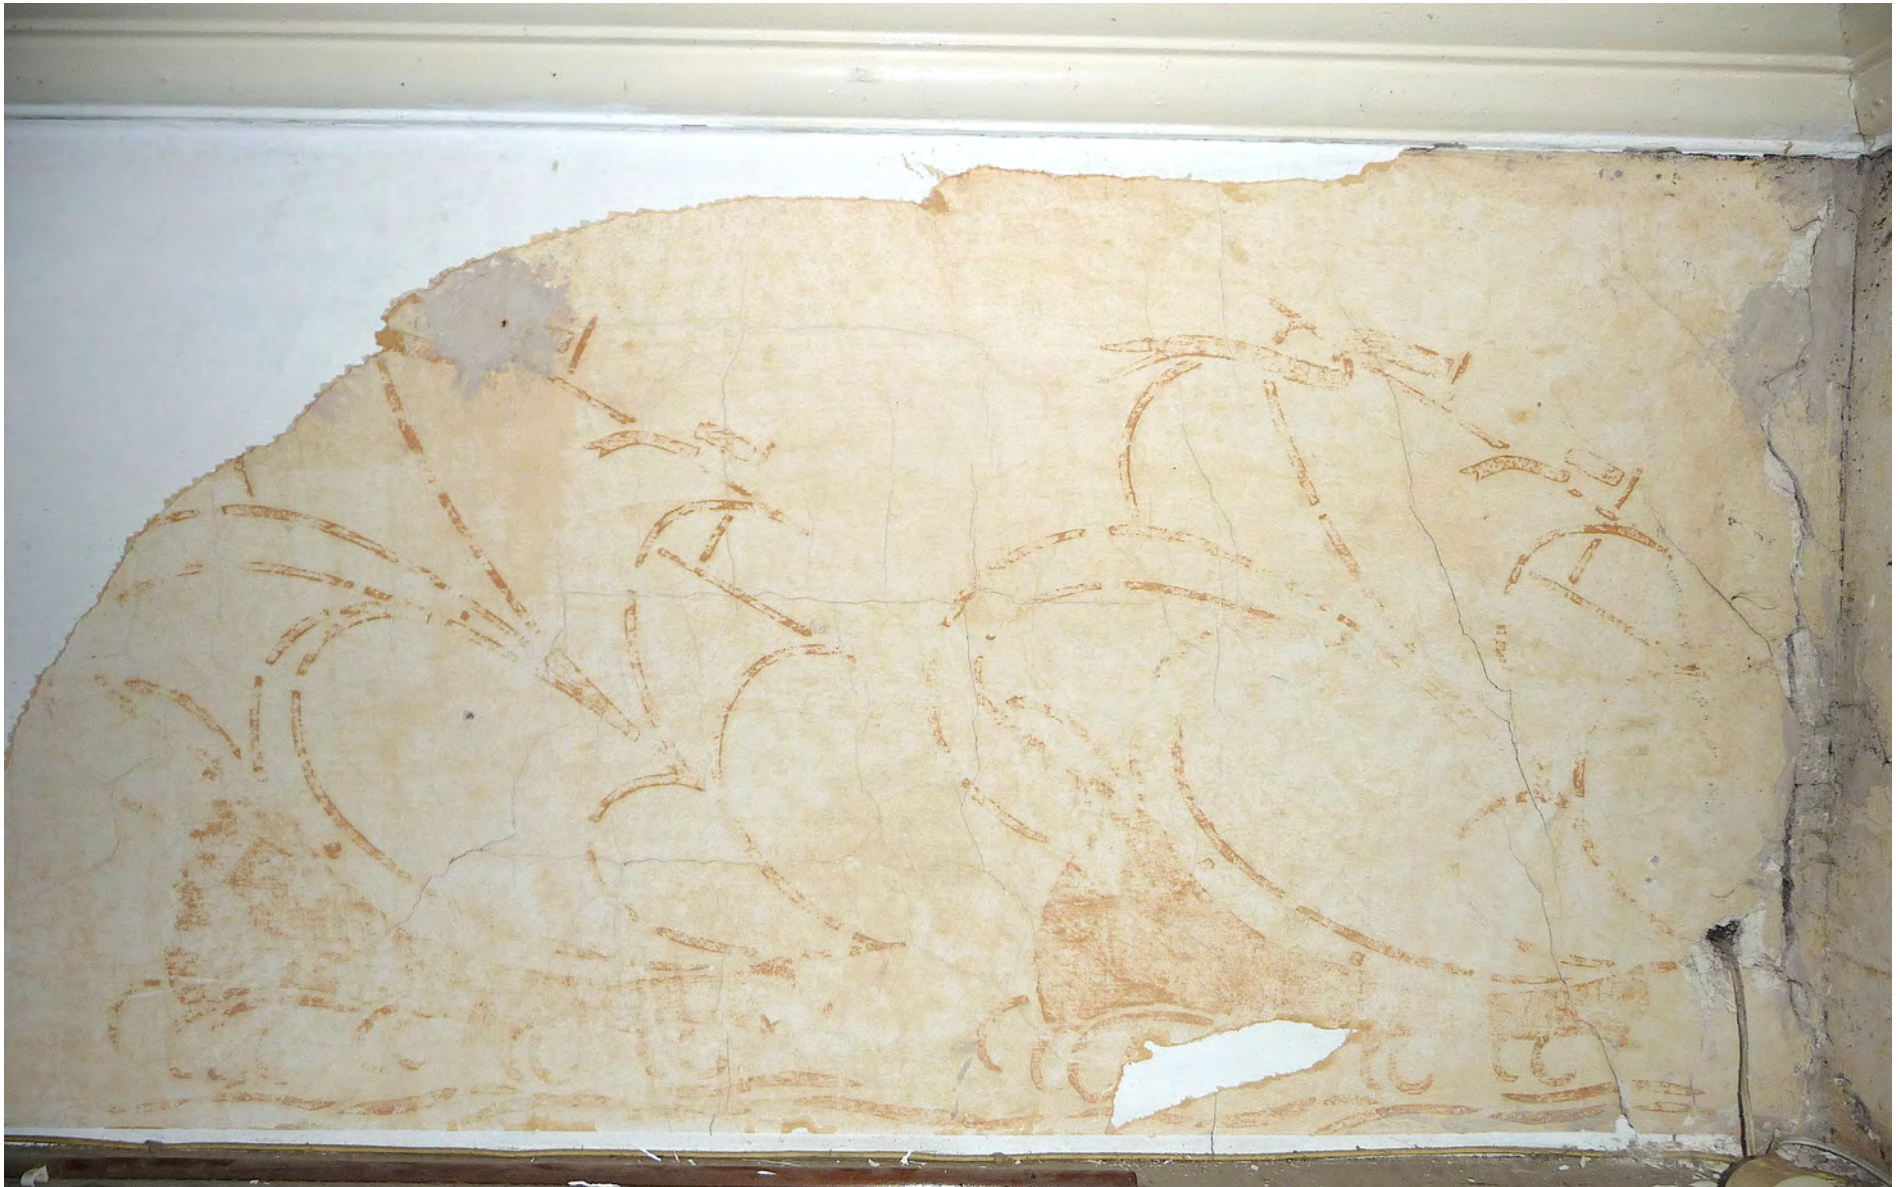
Fig.9: Entrance Hall frieze (as revealed and prior to reconstruction)

Two images of the frieze are included in figs 9 & 10, the first displaying the design as it was revealed and the second a reconstruction on a pale ochre background with the stencil picked out in dark ochre.

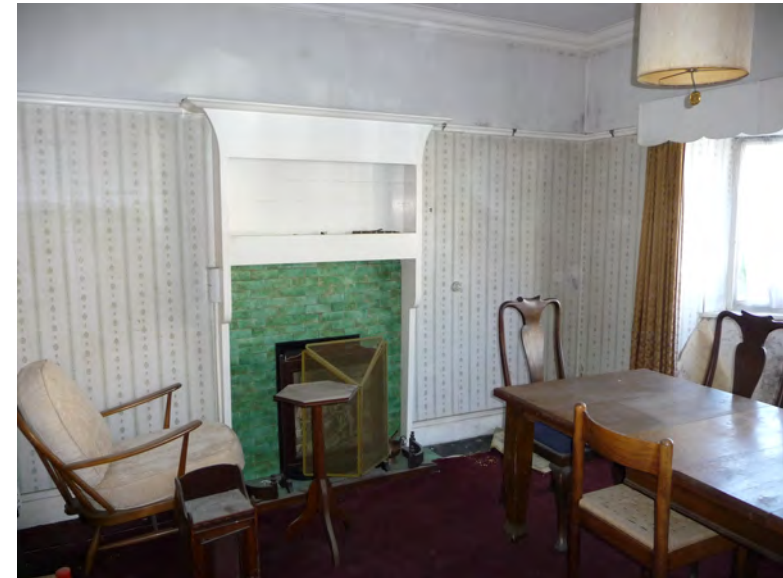
3.3: (Fig.11) The Dining Room (Ground floor front room with bay window)

Samples were removed from the joinery: skirtings, window, door, picture rail, fireplace, coving and architraves, with all displaying an identical appearance for the earliest decorative scheme, in a simple white oil paint. The only exceptions to this, being the door and timber coving which were picked out in pale cream oil paint. The upper wall face is currently painted white onto a lining paper above the plaster substrate, with the potential for a painted frieze beneath. Careful further uncovering will be required to determine if this is the case. No distempers or oil paints were detected on the lower wall face, suggesting the wall up to picture rail level was originally papered.

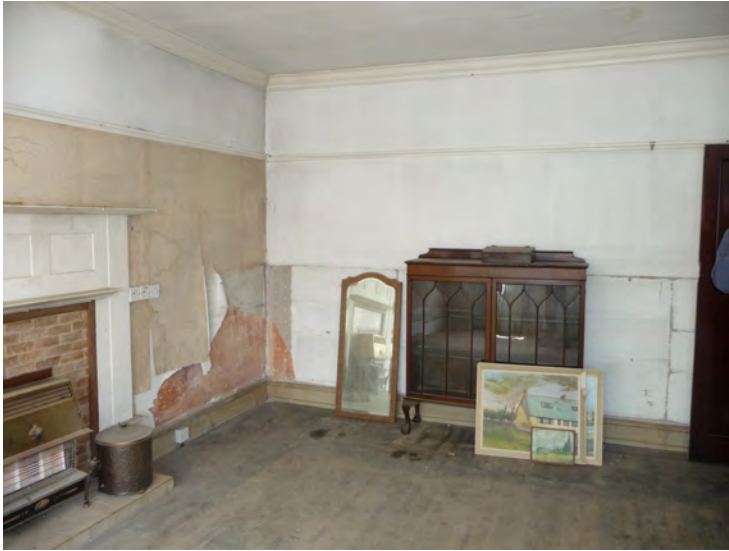
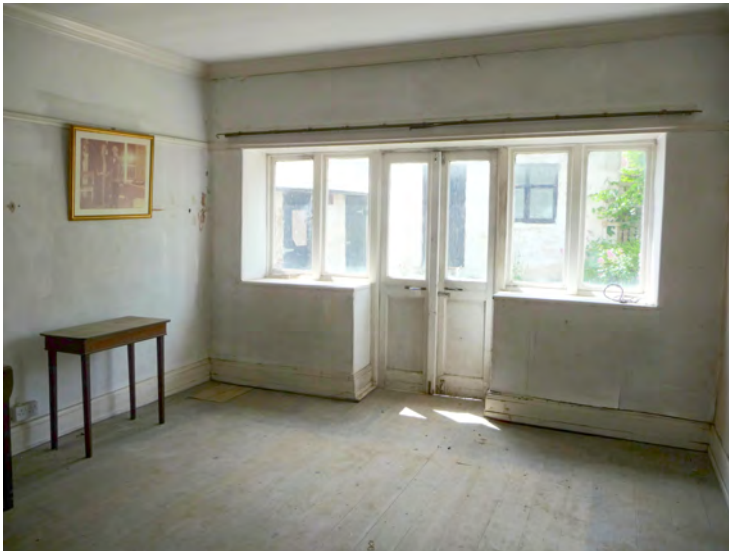
3.4: (Fig.14) The Drawing Room

Double doors lead off the Entrance Hall into the Drawing Room (the largest room on the ground floor), with a pair of French Doors leading into the garden at the rear of the house.

The Joinery: there is clear evidence on the skirting boards, timber coving and picture rail for a full chronology of decorative schemes with the earliest in dark green lead oil paint. The remaining joinery (doors and windows) have been stripped in the past with no evidence for the earliest decorative schemes surviving. The fireplace mantle has also been stripped but there is trace evidence directly on the surface of the substrate for a dark green oil paint that appears to match the earliest scheme on the skirtings, coving and picture rail.

Lining paper on the ceiling with white water paint.

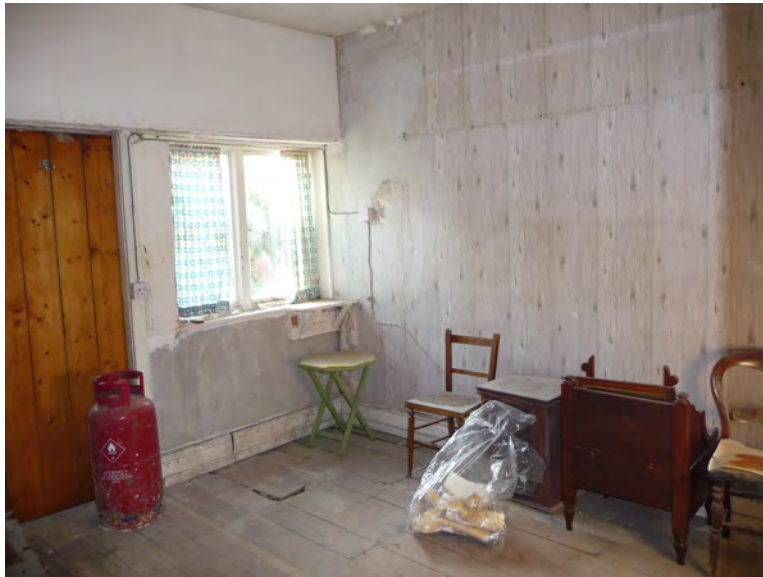
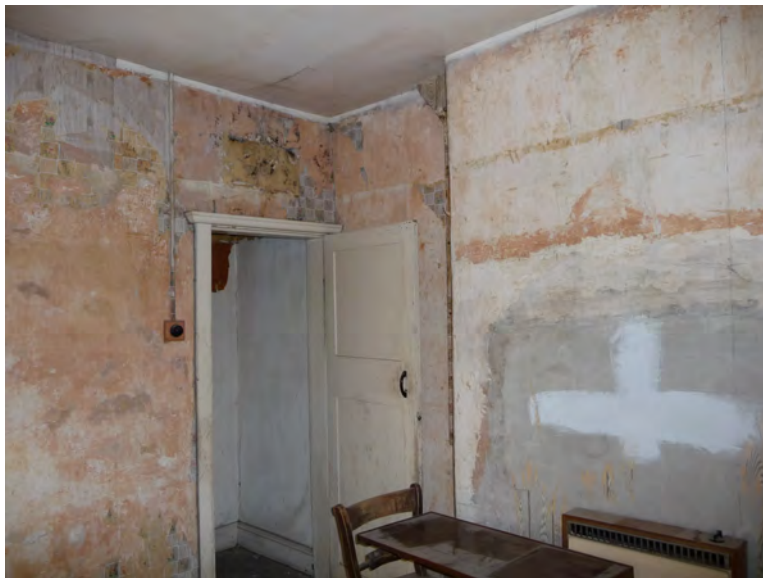
3.5: (Fig.18) The kitchen

There are several layers of later wall papers in the kitchen that appear to date to the post World War 2 period.

Walls: On the surface of the plaster in many areas is a terra cotta coloured “Sanitary Distemper”. Sanitary distempers were produced by a number of manufacturers at the end of the 19th and early 20th century as a water washable alternative to soft distempers and were particularly popular for use in areas like kitchens that required regular cleaning. One example was the product “Zingessol” manufactured by John B. Orr since the mid 1870’s². This early distemper is the first decorative scheme.

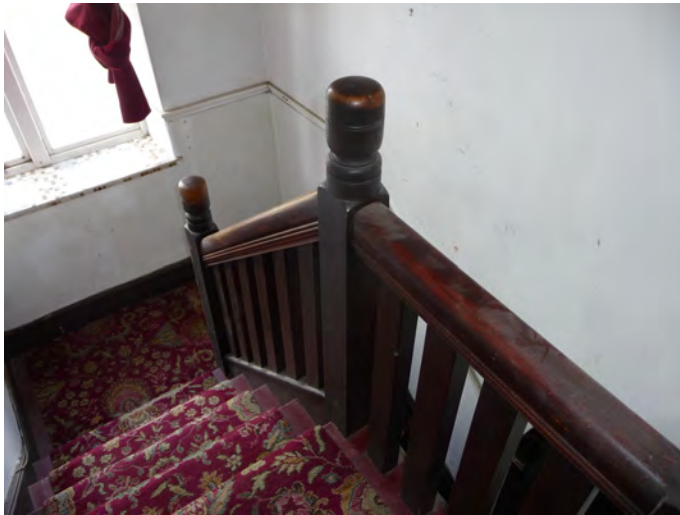
3.6: (Fig.20) The stairwell and 1st floor landing

The stairwell leads off the Entrance Hall and onto the 1st floor landing, with a dado rail separating the upper and lower wall faces in the stairwell extending as far as the first door frame on the landing. There is no evidence for distemper or paint finishes on the lower wall face, but the upper wall face was initially distempered in the now familiar ochre. It is anticipated both the lower and upper wall faces were papered.

The dado rail was originally varnished dark oak to match the wooden staircase.

Moving onto the landing itself, all the joinery was painted in white lead oil paint with the walls, up to the level of the picture rail, displaying traces of early distemper and an accumulation of wall papers.

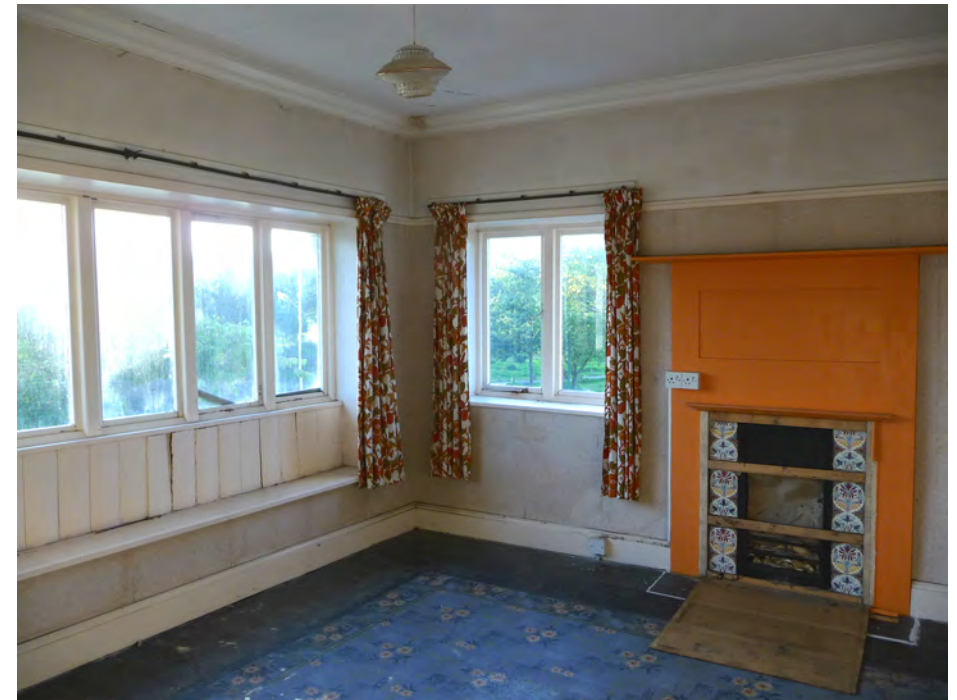
3.7: (Fig.24) Large Bedroom (rear of 1st floor)

A lack of further distemper schemes or oil paints on the walls up to picture rail level, suggest this room was originally papered. The blue theme continued for the following two subsequent decorations and doubtless the blue linoleum on the floor was installed to complement one of these decorative schemes; although its precise date remains speculative it certainly predates the installation of the fitted wardrobes in this room and is a rare survivor in remarkably good condition. The fireplace tiles are contemporary with the late C19 and further complement the originality of this space.

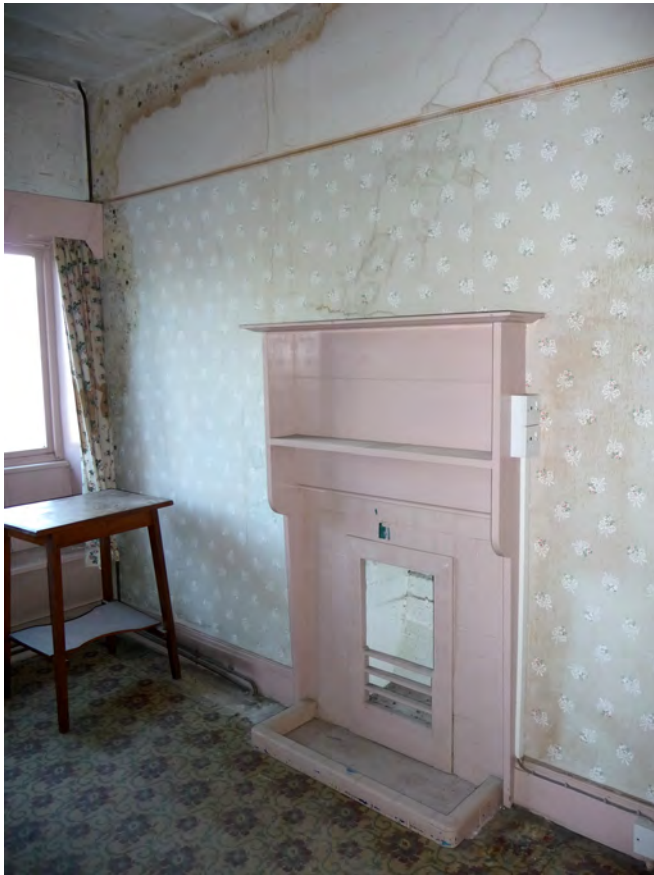
3.7: (Fig.27) Small front bedroom

All the joinery in this room has been stripped prior to the application of the current pink theme. No historical evidence survives.

Samples removed from the wall plaster display a modern gypsum plaster beneath the current wall paper.

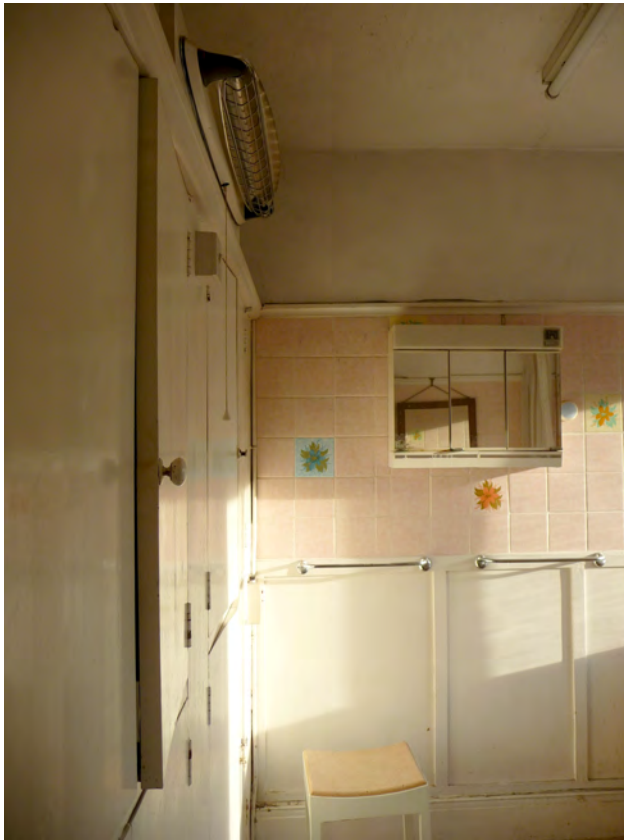
3.8: (Fig.29) The Bathroom

Samples removed from the joinery in the Bathroom display a consistent theme of lead white oil paints as the initial decorative scheme. The built in cupboards and wall panelling are original features with a representative sample displayed opposite.

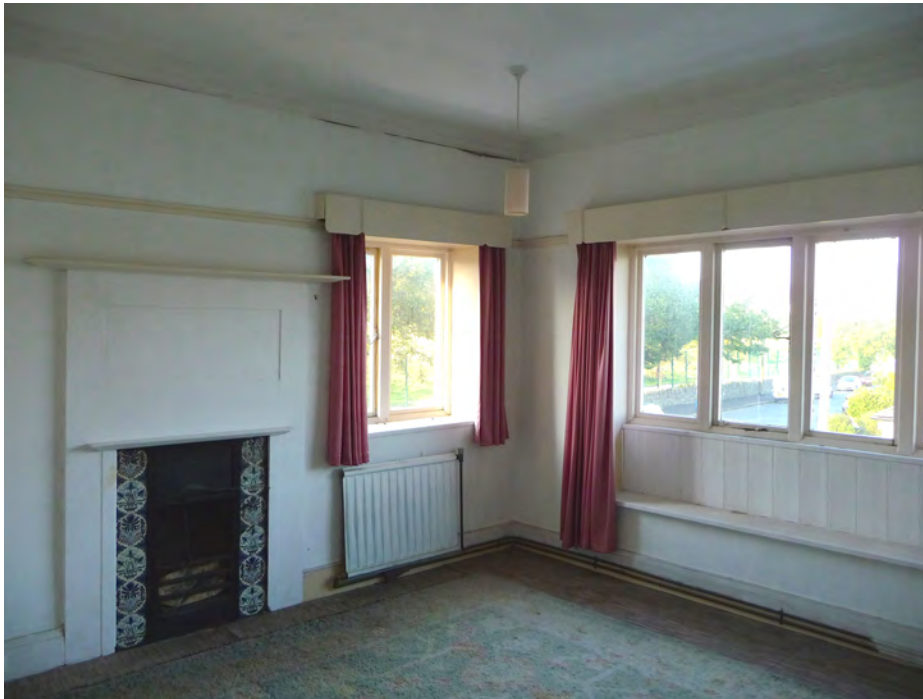
3.9: (Fig.31) Large 1st floor front bedroom

This bedroom has a distinctly green theme applied to all the joinery coeval with scheme 1 (1897). A representative sample removed from the fireplace mantle is included opposite. Note the varnish layer on the surface of the green at scheme 1; this was applied only to the fireplace mantle, with an identical green oil paint applied to all the remaining joinery, but without a varnish layer. The walls are currently papered with modern alkyd paints applied over the surface and white water paint applied to the ceiling. Single layer of ochre distemper on the walls, both above and below the picture rail, suggesting this bedroom was originally wall papered.

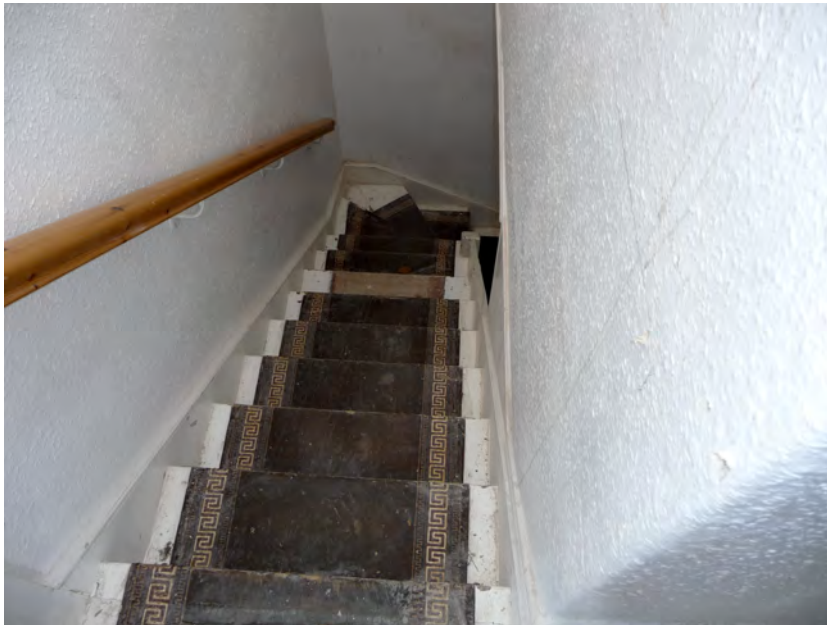
3.10: (Fig.33) Stairwell to 2nd floor (inc. Lobby Area)

The walls in the 2nd floor stairwell and lobby area were originally decorated identically with the now familiar ochre distemper applied uniformly to the walls, with all the joinery in both the stairwell and Lobby area in a white lead oil paint. There are further distemper schemes applied to the walls, suggesting this area was not wallpapered originally and may be a reflection on the use of the upper floor spaces as a lower status area.

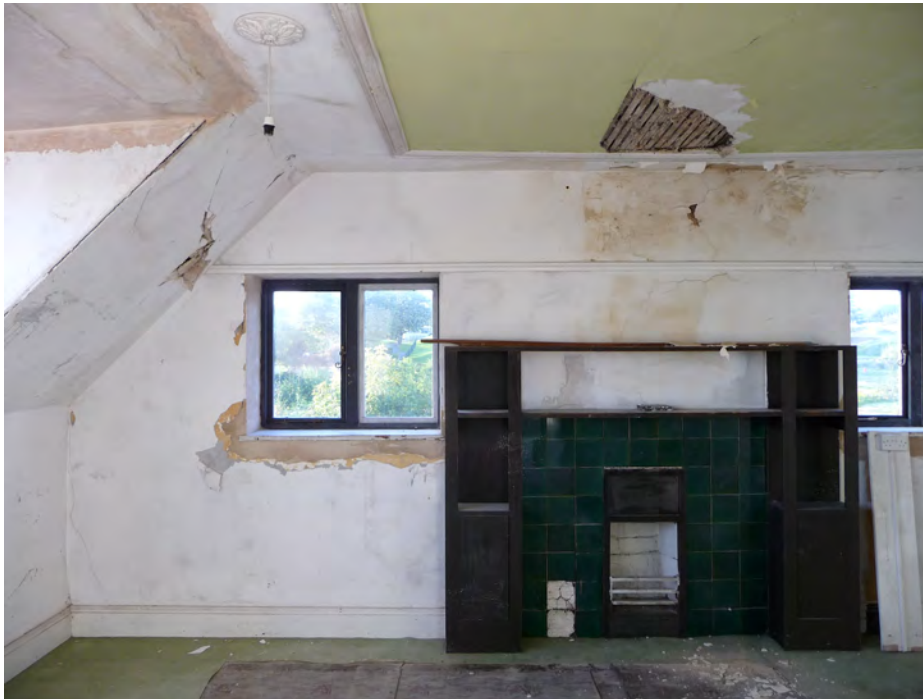
3.11: (Fig.36) 2nd Floor Studio Bedroom

The walls in the Studio/Bedroom were originally treated in the same manner as the 2nd floor stairwell and Lobby Area – initially in ochre distempers, followed by blue and further ochres, suggesting this space was not originally papered. All the joinery was painted in a reddish/brown oil paint, with evidence for this still surviving on the inside face of a cupboard door (see fig.37). The fireplace is certainly a later addition.

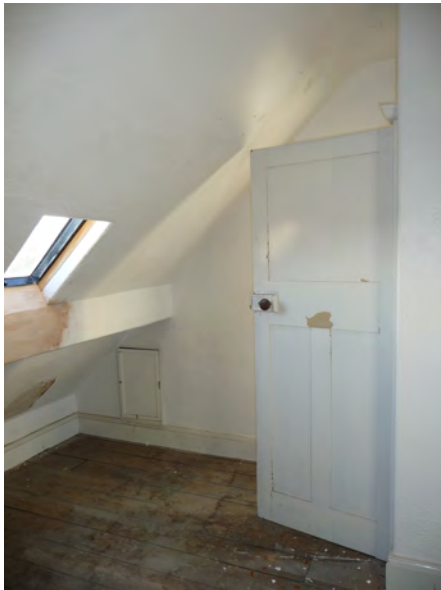
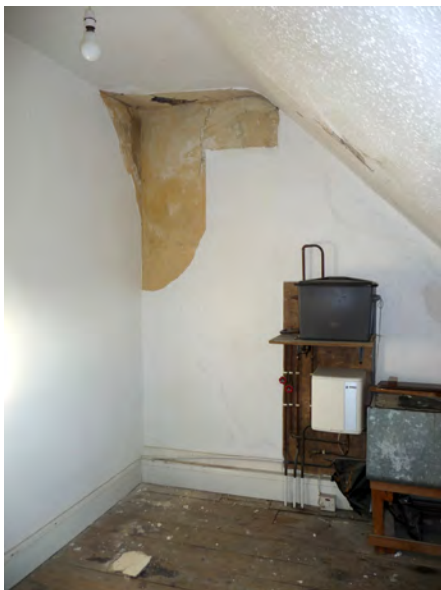
3.12: (Fig.40) 2nd Floor Box Room

The Box Room walls were originally ochre distempered with all the joinery painted in the identical white lead oil paint applied to the joinery in the stairwell and Lobby area (see fig.41).

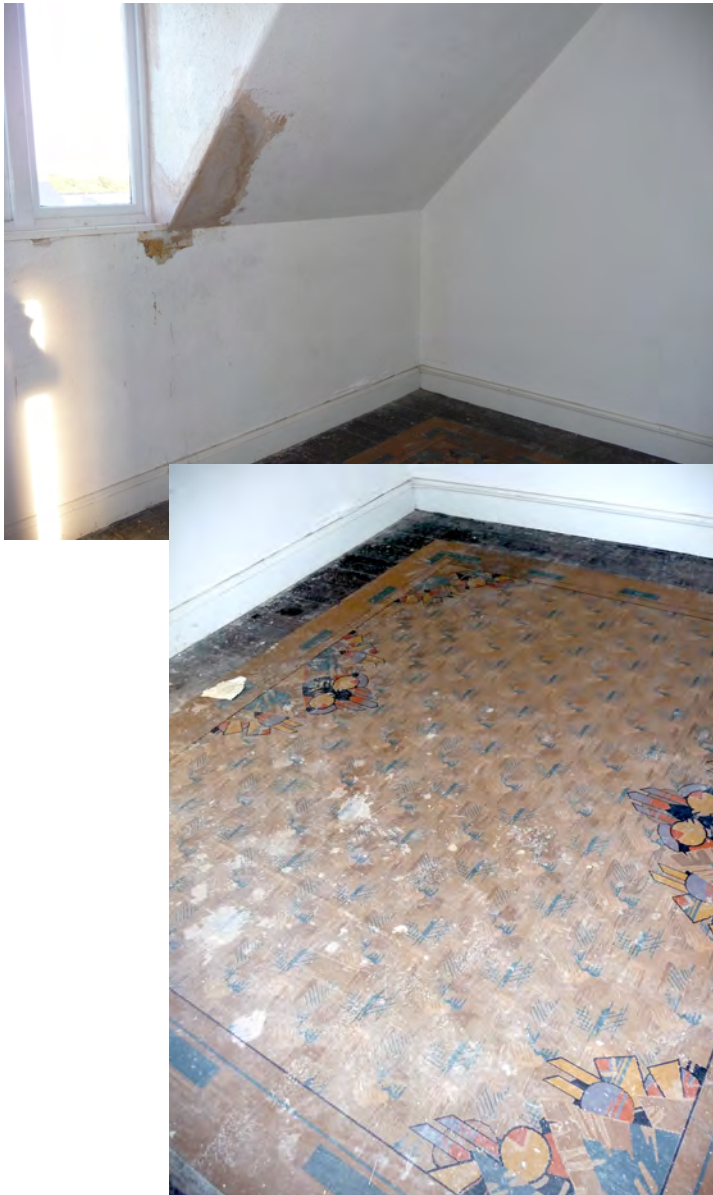
3.13: (Fig.42) Small front bedroom (2nd Floor)

Treated identically to the small Box Room with ochre distempers on the walls and white lead oil paints to all joinery. The linoleum on the floor appears to date to the Art Deco period (1930's).

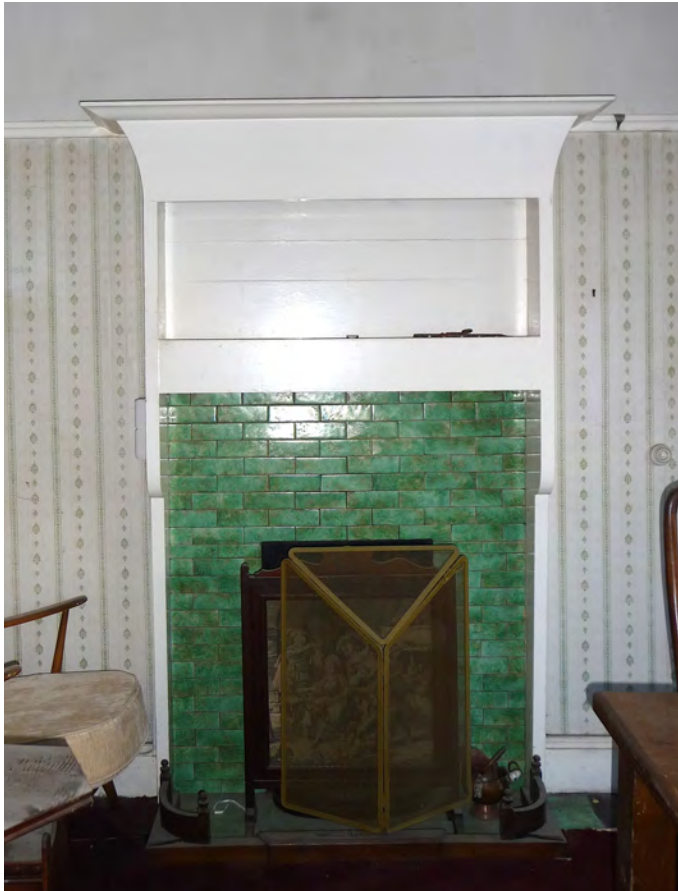
Fig.46: Dining Room fireplace

The fireplace in the front ground floor Dining Room (see fig.46) is fitted up to the level of the picture rail and forms a distinctive focal point to the room

The glazed tiles appear to be original and reflect Baillie Scott's own ideas - *“Glazed tiles may be used in the fireplace, either in connection with a cast iron grate or in lining the recess for a dog grate. Perhaps the most effective, especially if used with red brick,*

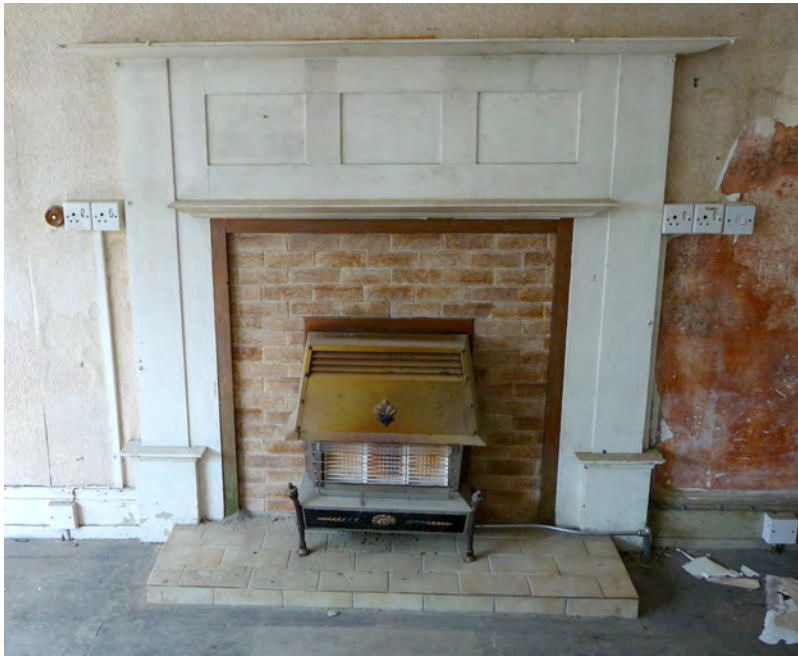
Fig.48: The Drawing Room fireplace

This timber fireplace has been stripped in the past, but does bear traces clinging to the timber substrate of the same early green oil paint detected on the skirting boards, suggesting it is coeval with 1897.

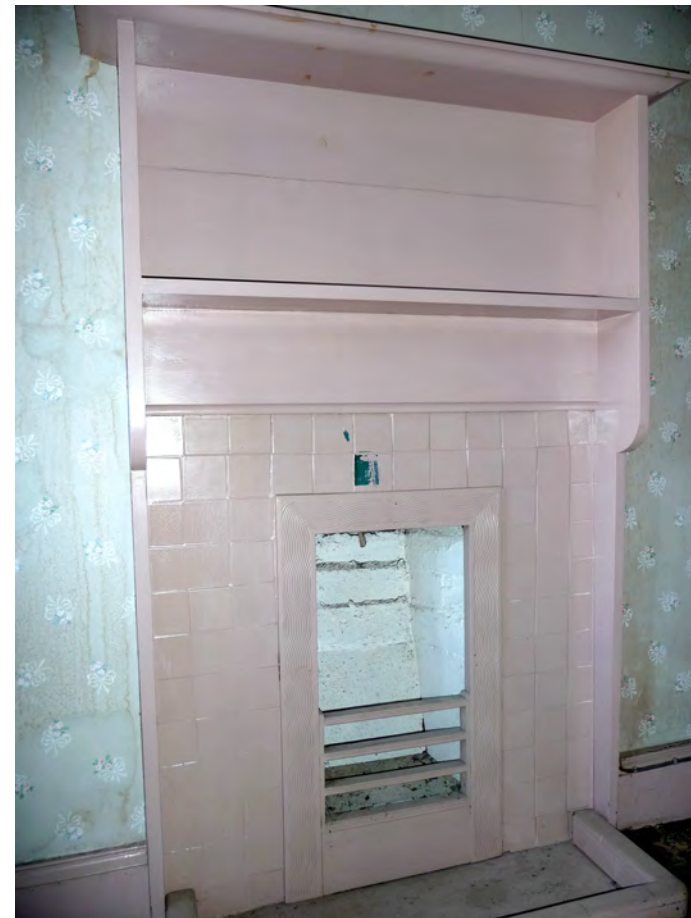
Fig.49: Pink bedroom fireplace

Some of the over paint was mechanically cleaned off a small area on one of the tiles as shown in fig.49, revealing a peacock blue glazed tile beneath on an “antique ground”. Again these appear to be original to the piece and are a reflection of Baillie Scott’s own ideas regarding the presentation of the fireplace.

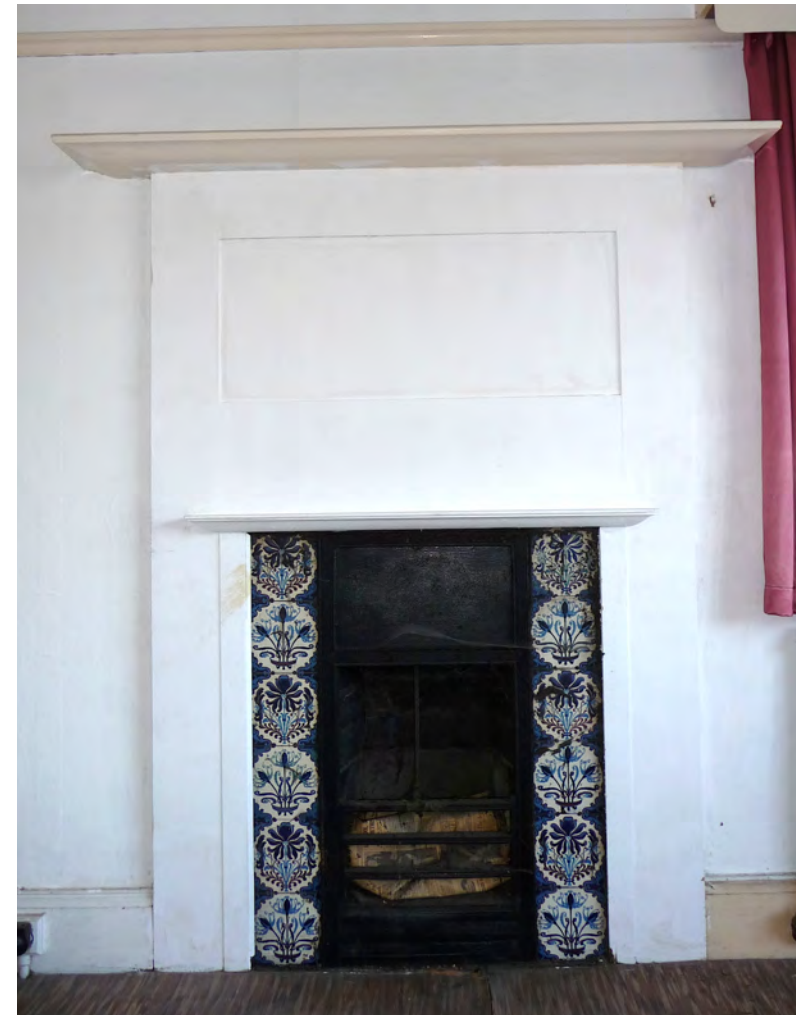
Fig.50: Front bedroom fireplace

There are two remaining identical fireplaces in the bedrooms on the first floor with the image right taken in the large bedroom at the front of the house.

Both fireplaces have identical hand painted earthenware lead glazed tiles that appear to be original and have survived in remarkably good condition.

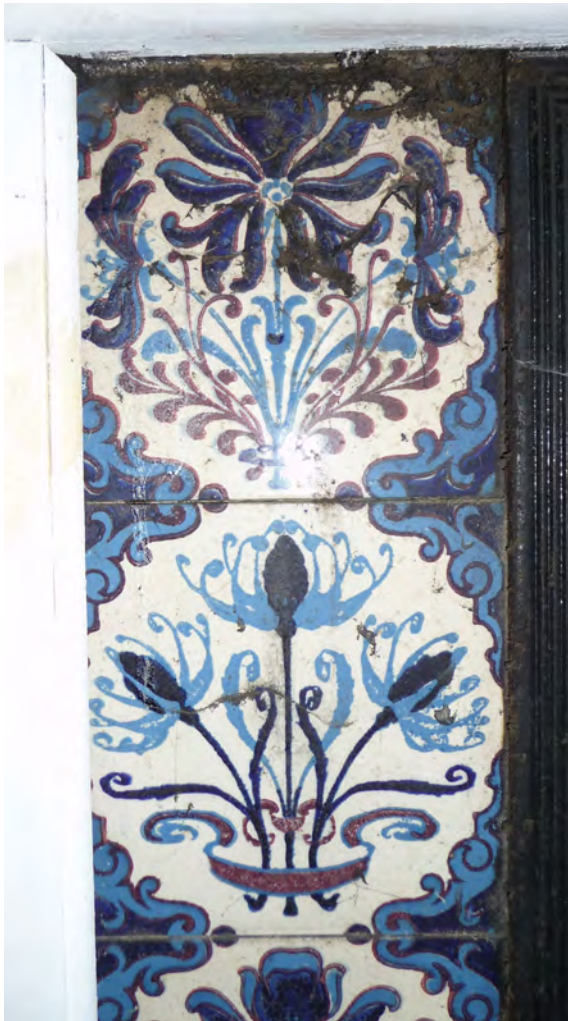
Fig.51: The fireplace tiles

The tiles may have been sourced through a local supplier, for example: Robert William Creer of Athol Street, Douglas – a monumental mason and supplier of “enamelled hearth tiles” (see fig.52). Creer was the agent for The Campbell Tile Company of Stoke on Trent and advertised widely in a number of local newspapers throughout the late 19th and early 20th century. Campbell's was one of the Minton Tile Companies.

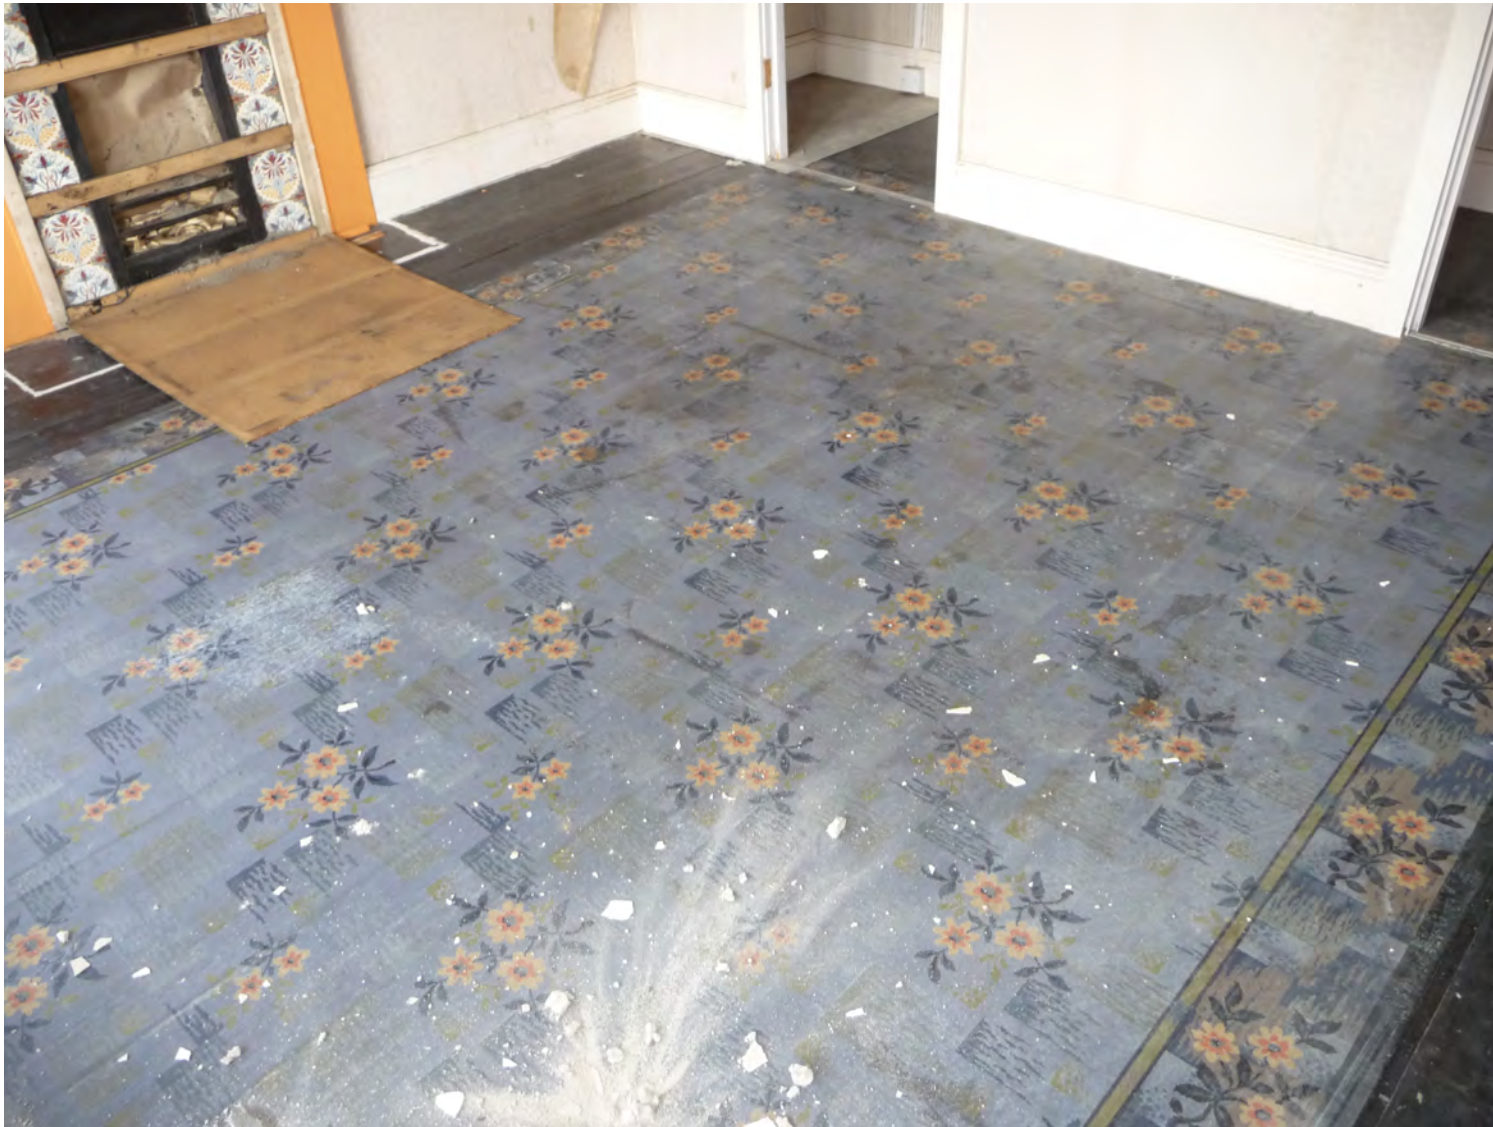
Fig. 2: Example 1 (Large Bedroom rear of 1st floor)

A floral pattern on blue background with border to fit the room.

The walk in wardrobe at the top of the image has been inserted on top of the lino covering and clearly post-dates it.

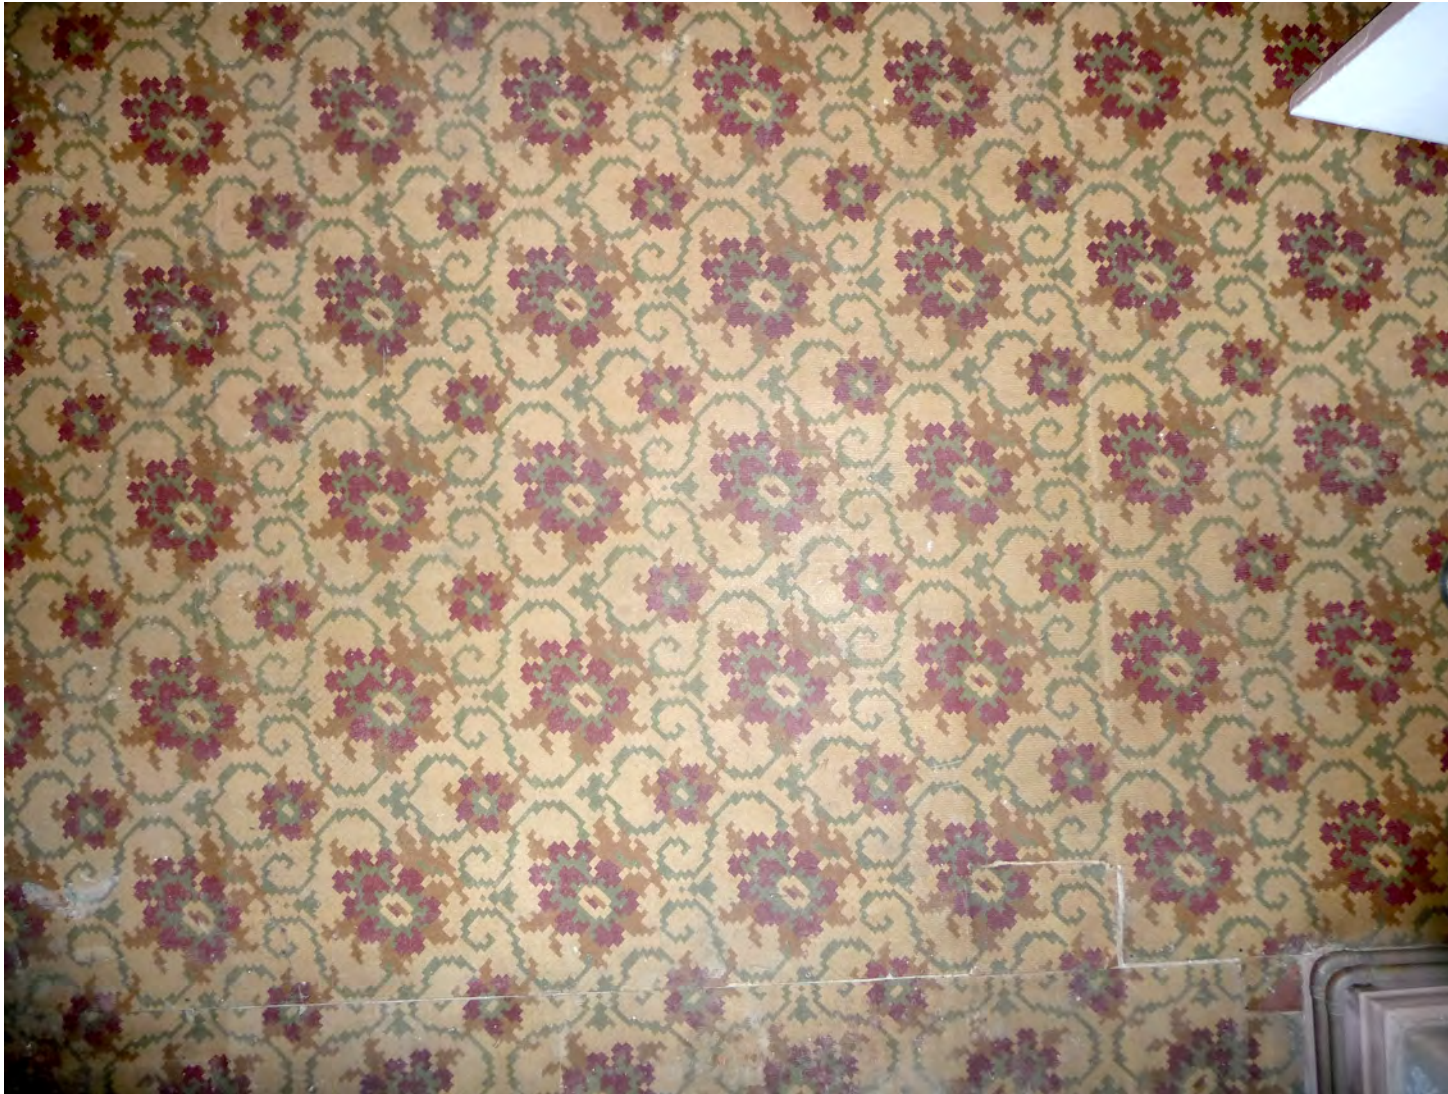
Fig.3: Example 2 (Small front bedroom)

A busy repeating pattern intended to mimic carpet.

Compare with similar “carpet designs” listed in the Dominion Linoleum Catalogue dating to 1926² – see Summary.

All the linoleums at Thornbank appear to post date the construction of the house and were probably introduced during the 1920's / 30's. Example 2 (small 1st floor front bedroom) is a carpet weave design, to style of which, again features prominently in the 1926 Dominion Catalogue (see below)

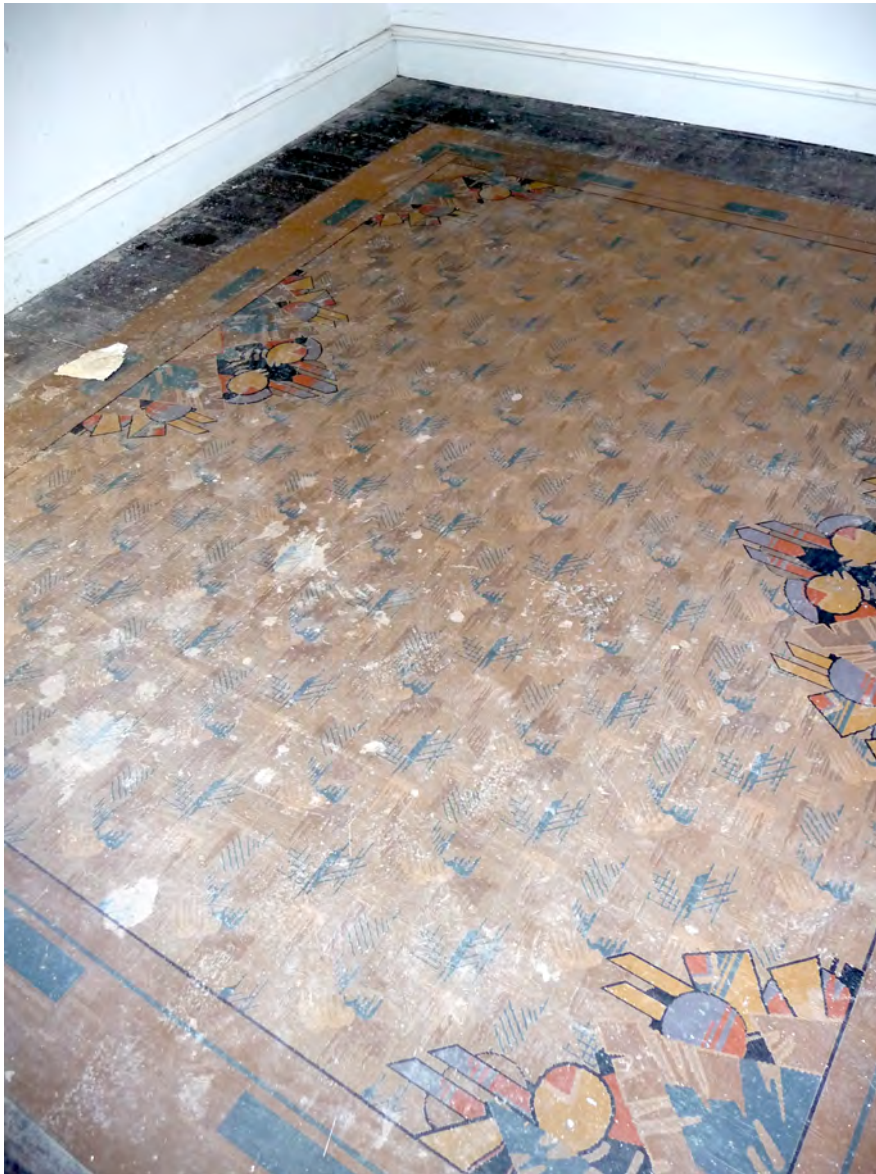
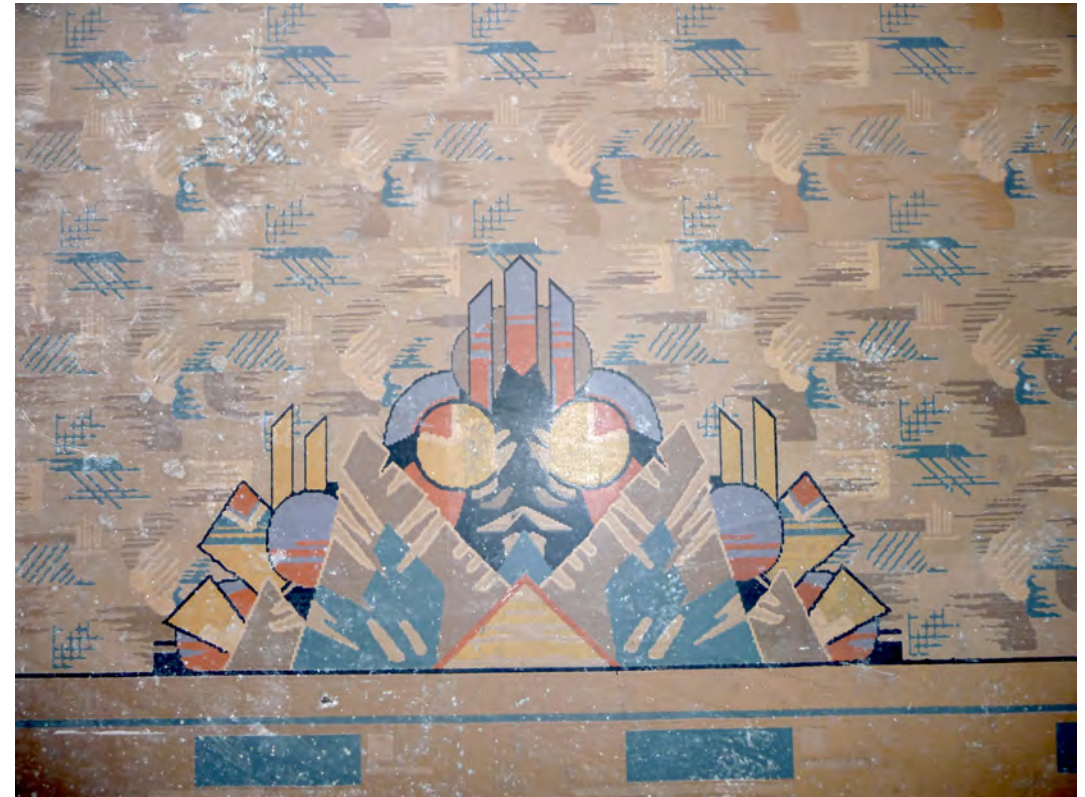
Fig.5: Example 4 (Small front bedroom, 2nd Floor)

A geometric Art Deco design with border to fit the room.

The linoleum in the small 2nd floor bedroom is a geometric Art Deco design and again clearly dates to this period.

These linoleums have been in place for some considerable time, but in most cases have survived well – presumably because they have been covered and protected by later floor coverings. All have become brittle with age, due to the decay processes indicated earlier. It may be inadvisable to attempt to remove them from the property because any attempt to roll them will almost certainly cause them to crack. All require cleaning with a suitable pH neutral conservation grade surfactant and it may be prudent to record them and leave in situ with a suitable protective layer above.

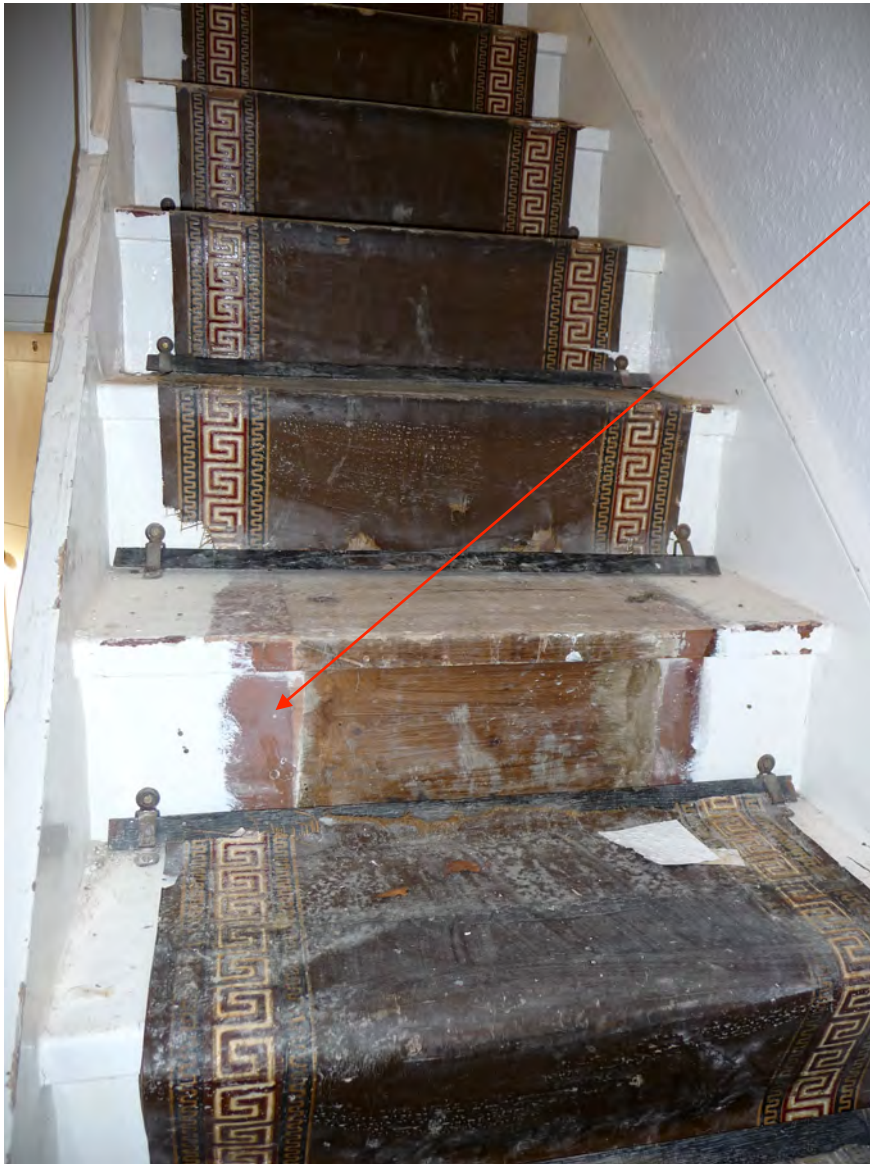
Fig.6: Example 5 (Stairs to 2nd Floor)

This stair runner leads from the 1st floor landing up to the 2nd floor. Note the presence of the original brown oil paint on the edge of the stair; indicating the presence of an earlier stair covering, suggesting this lino/oilcloth runner is a later insertion and not coeval with the construction of the house. This identical pattern is identified in the Dominion Linoleum & Oil Cloth Catalogue dated to 1926 (see Catalogue extract below) and described as a “Passage Linoleum”.
